FAST AND FRIENDLY **BRASS**

Tuning the Extraction Tab on the Dillon Super 1050

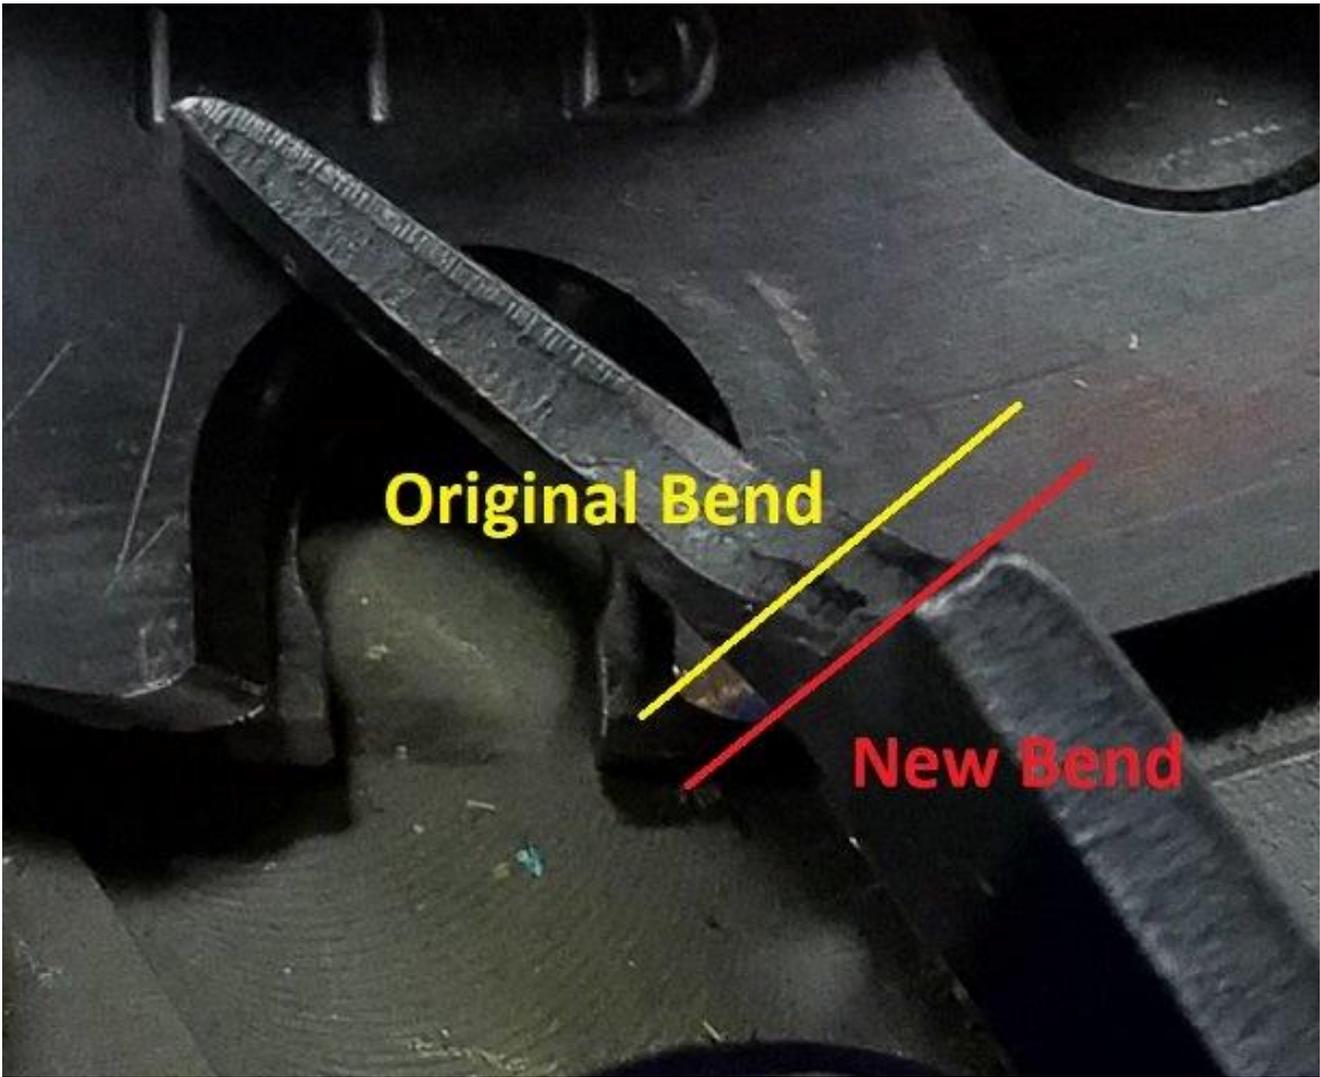
Looking at the photo below, you will notice the yellow line showing the original bend point on the Dillon factory ejector tab on the Super 1050. The tab is bent too far out towards the tip. What this causes, especially with our shell plates that have more precise tolerances, which decrease case wobble, is that the tab does not fully extract the case before the case gets to a 90 degree "stopping" point (aka jam) on the tab.

To fix this is VERY simple and can be done in less than 1-2 minutes of your time, using only a vice and either a small hammer, pliers, or adjustable wrench.

1. Remove the tab from the machine.
2. Note the angle of the tab. You can trace the outside bend of the tab onto a piece of paper using a pen for reference.
3. Insert the tab into the vice, in the orientation it is normally installed in the press, and use the vice to flatten the tab.
4. Insert the tab into the vice with the point down, with the top of the vice jaws at the red line (new bend point).
5. Using the adjustable wrench, tighten the wrench onto the protruding square area of the tab, and create the new bend. Alternatively, you can use pliers, or a hammer, but an adjustable wrench gives the best control.
6. Compare the new bend angle to the pattern you drew on the paper sheet in step 2. If the angle matches, install back onto the machine and enjoy your newfound ease of ejection.

As a reference, to make sure the angle is correct before/after the bending, when the tab is installed, the tab should hug the back of any die in the last station with the toolhead in the down position. If you can see light between the tab and die, the tab is at the incorrect angle, which will make it harder to extract cases.
